**PHASE I - INSPECTION REPORT  
NATIONAL DAM SAFETY PROGRAM**

**COLSTRIP EVAPORATION POND DAM  
ROSEBUD COUNTY, MONTANA  
MT - 3211**

**JUNE 1981**

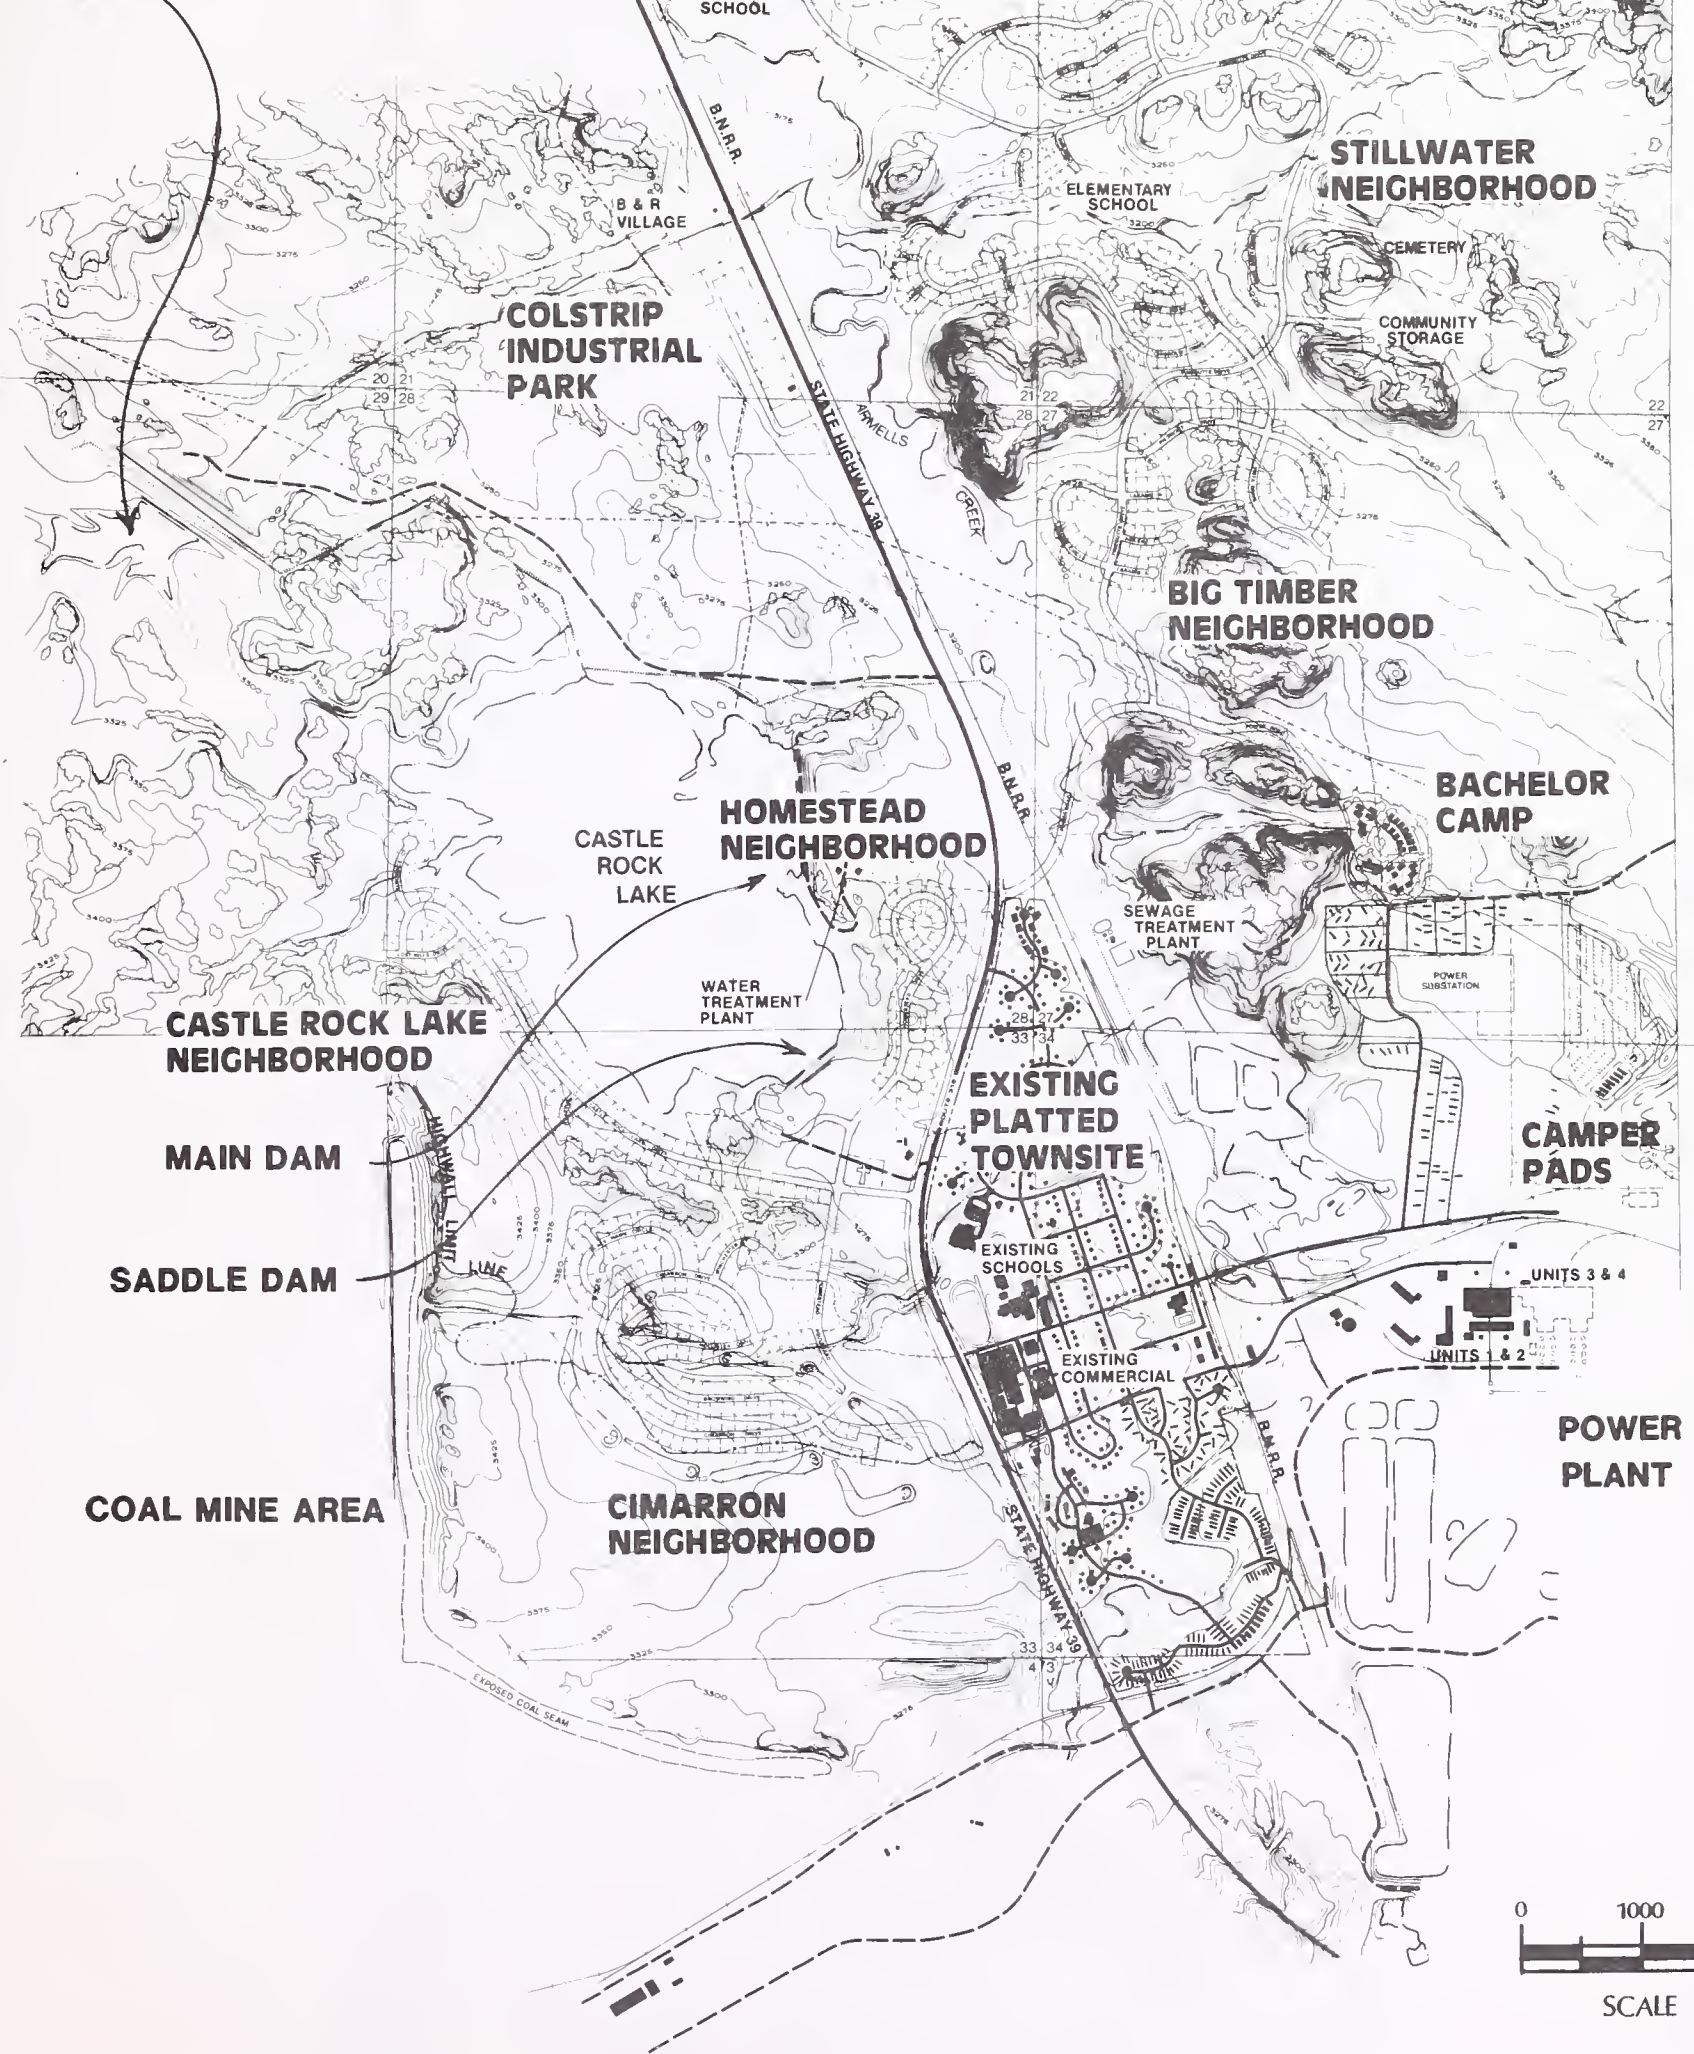
**PLATE -3-  
COLSTRIP TOWNSITE  
EXPANSION**

The Colstrip townsite expansion now underway will enlarge the community from less than 2,000 to an estimated 8,000 population. The current design plan calls for more development of the area immediately downstream of the Evaporation Pond Dam, in addition to the existing homes and businesses. (Plate 3) A failure of this project could endanger many lives and could cause much property damage. This intermediate sized project has a high downstream hazard potential (Category 1).

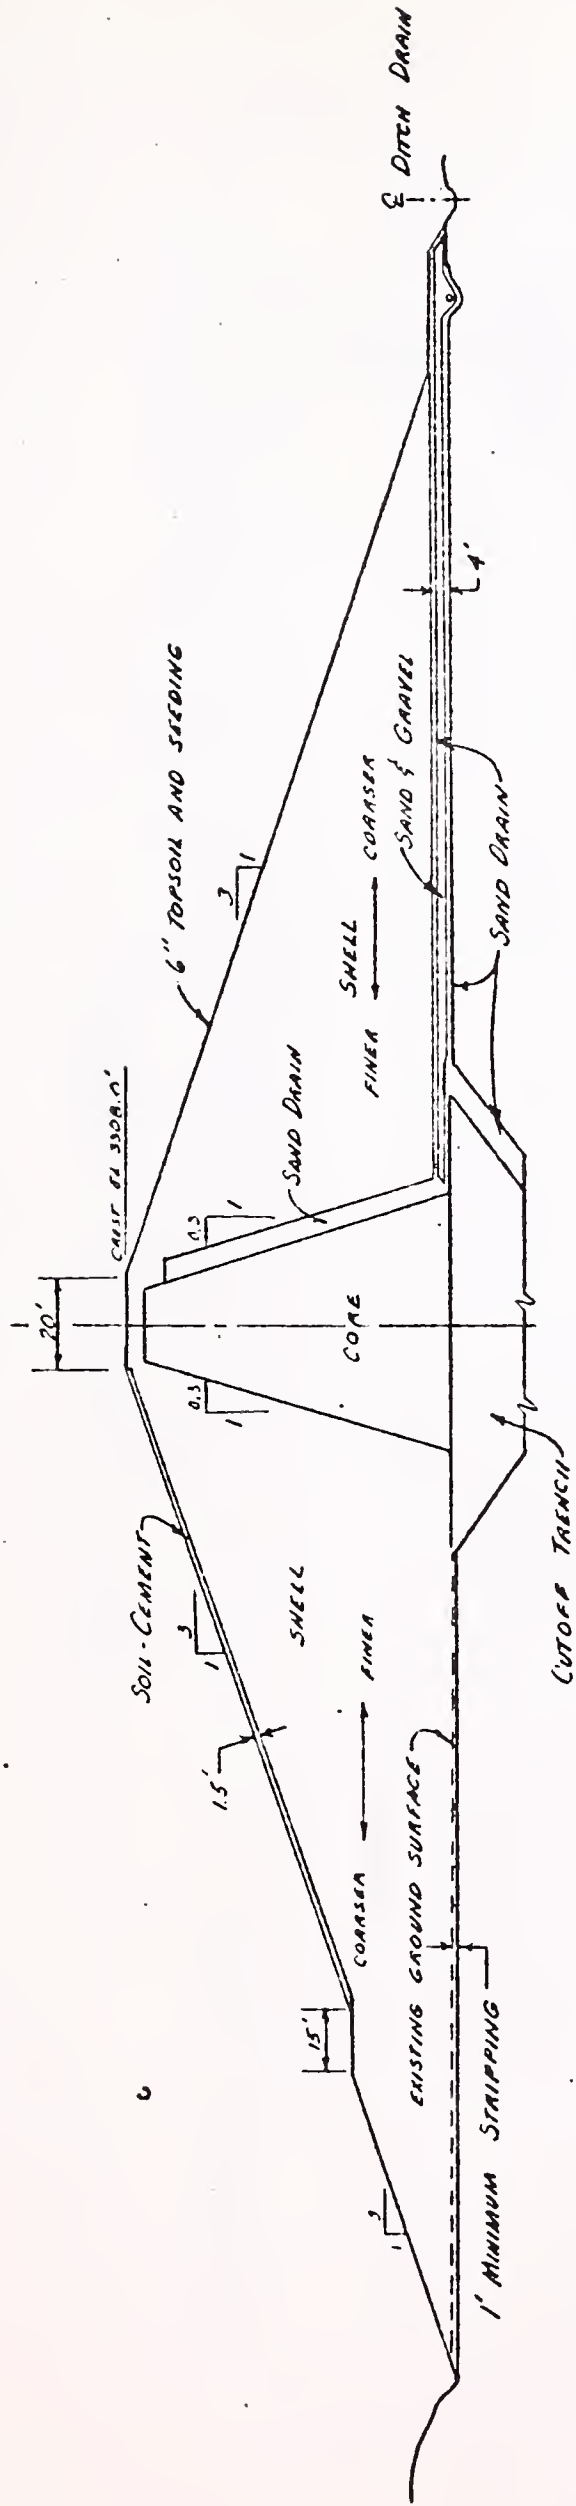
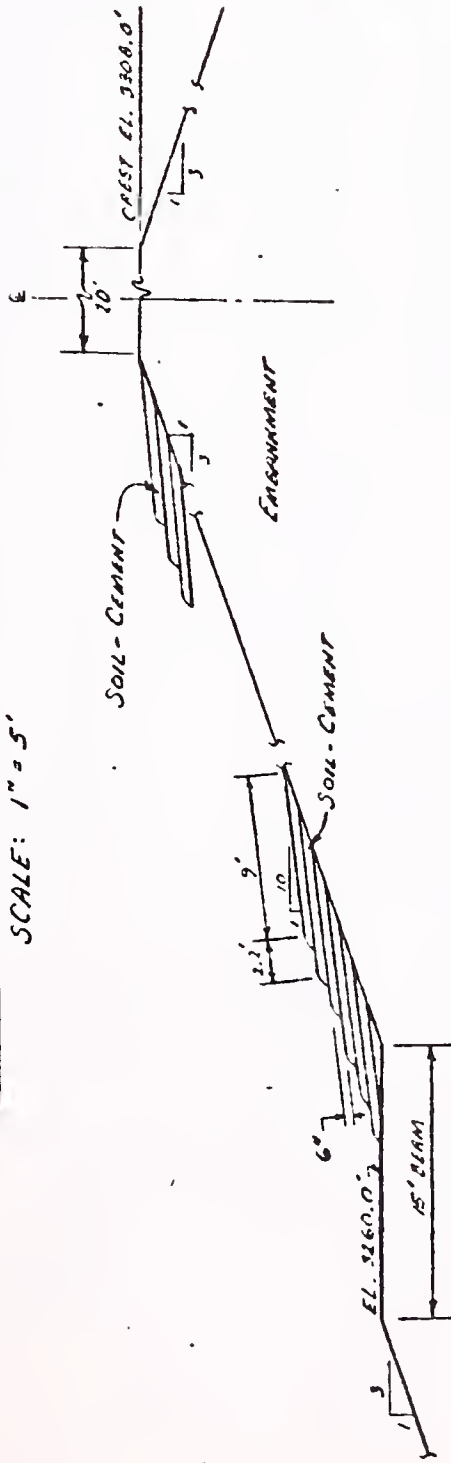
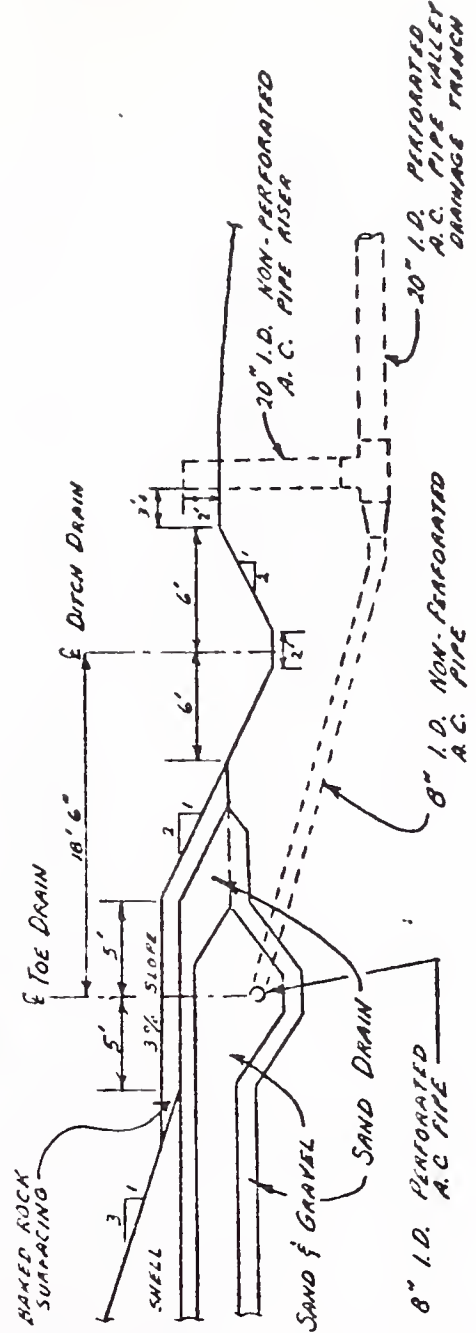
## PLATE 5- EVAPORATION POND DAM - SECTIONS

The Design Report indicates the dam to be a zoned earthfill embankment with a crest length of 1840 feet and a maximum height of 70 feet above the original ground surface. A crest width of 20 feet was designed to handle construction and maintenance traffic. Both upstream and downstream slopes were designed at 1V on 3H. A 15-foot-wide berm is shown on plan drawings at elevation 3260 feet. A typical cross section of the embankment is shown on Plate No. 5.

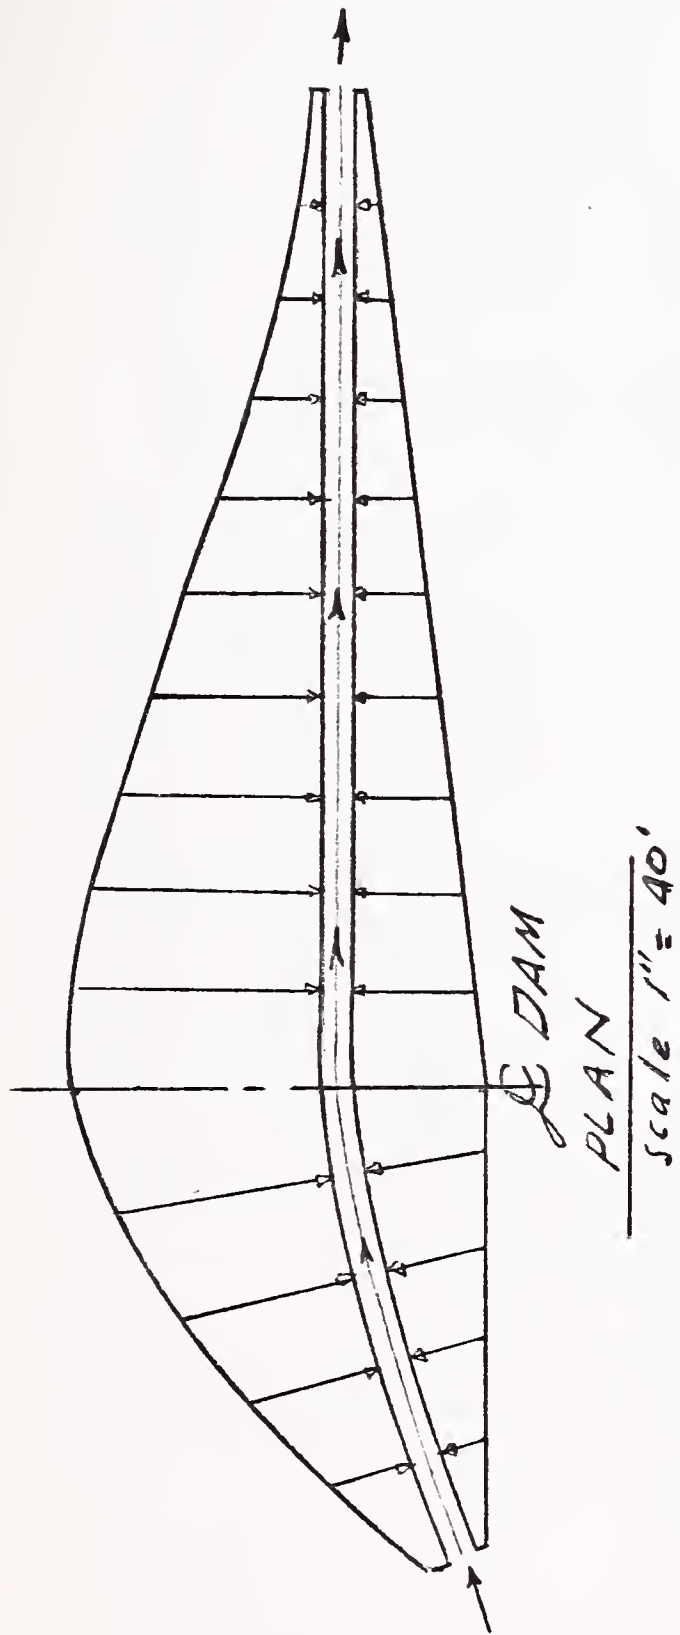
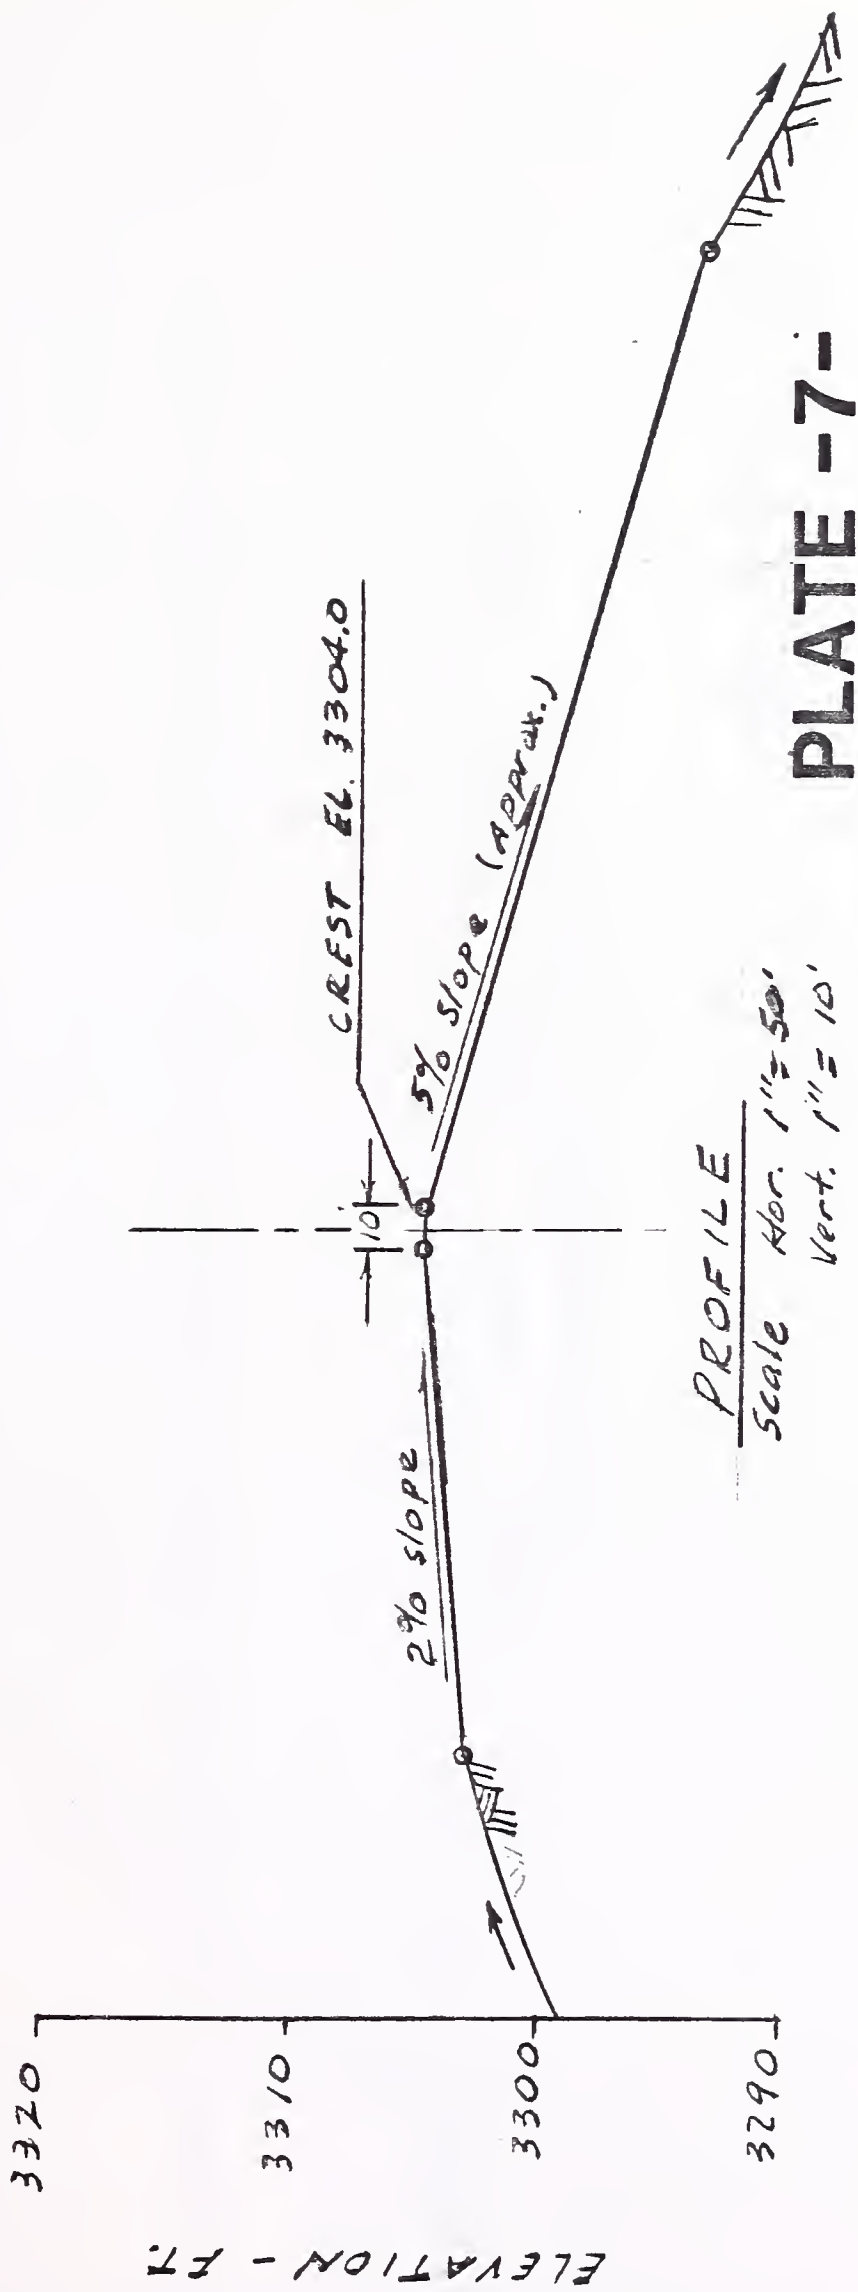
## PLATE -7-

The emergency spillway for the Evaporation Pond Dam is excavated through broken sandstone material in the left abutment. (Plate 4). The spillway is unlined and has no grass cover on the bottom or sides. (Photo 6) The control section consists of an earth weir located near the axis of the dam embankment, with a crest elevation of 3304.0 feet NGVD. (Plate 7) This elevation is based on levels surveyed at the time of the site visit using known elevation 3308.9 feet NGVD for the top of a concrete base on the pump station located near the center of the dam. The crest of the emergency spillway is 4 feet below the dam crest elevation 3308.0 feet NGVD. The approach channel has an adverse slope of .02 and the exit channel has a slope of approximately 0.05. At the control section, the crest width is about 15 feet with 1V on 2.5H side slopes. Prolonged spillway flows would erode the exit channel. However, this should not endanger the dam embankment which is more than 50 feet to the right or east. It is our estimation that flows during the passage of the PMF would erode the channel but not cause irreparable damage.

The emergency spillway located in the left abutment is cut into weathered sandstone material. The spillway approach channel is presently slightly obstructed by the service road crossing the dam crest. (Photo 6) Road maintenance could create a flow obstruction in the future.

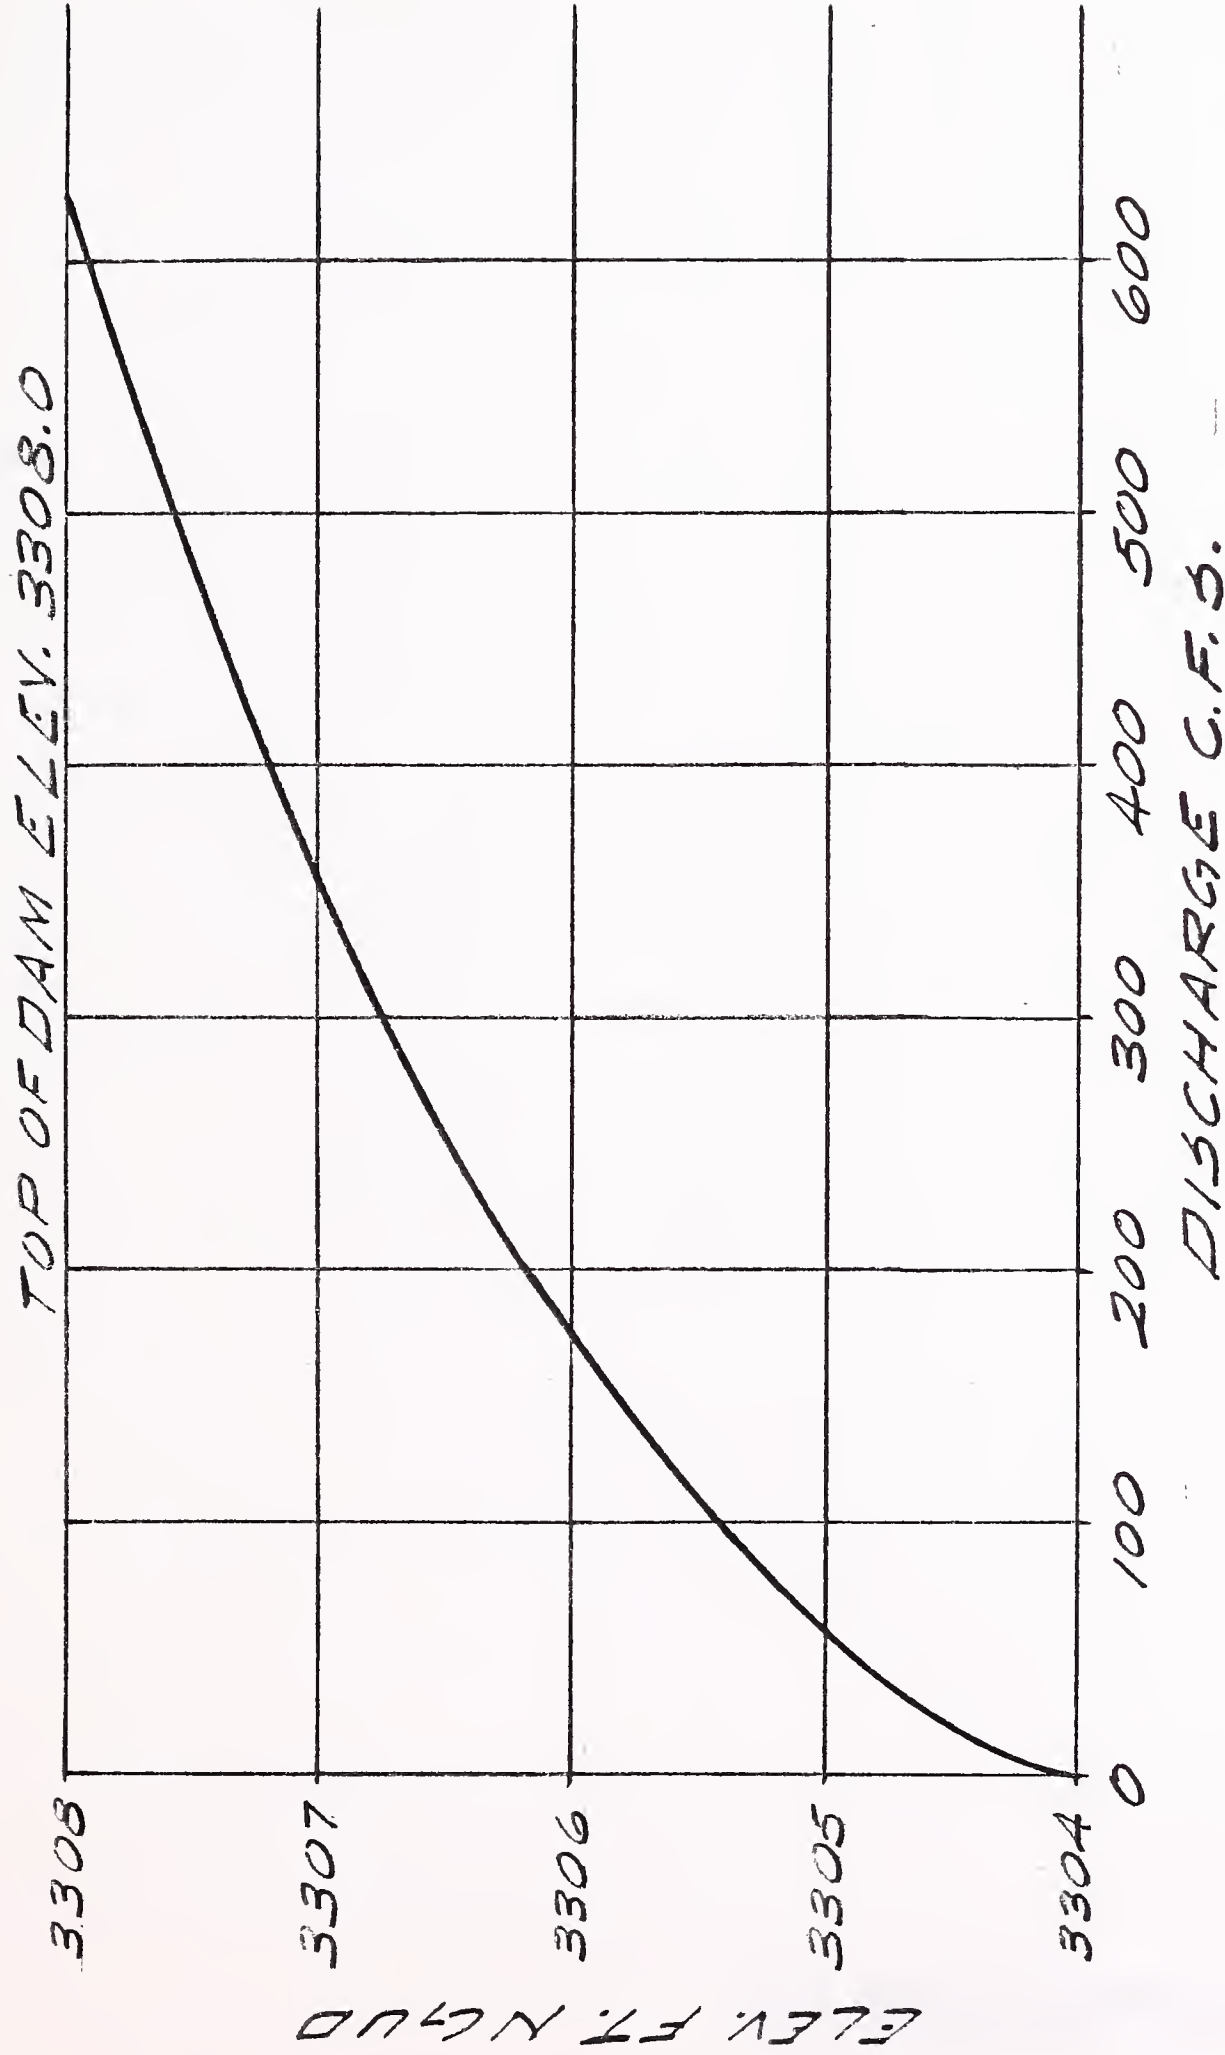
PLATE -8-

The discharge rating curve (Plate 8) for the emergency spillway was developed by assuming that critical depth occurs at the control section. (Ref. 6) Friction loss in the short approach channel was assumed to be negligible. The maximum discharge capacity of the spillway with the reservoir at dam crest, elevation 3308.0 feet NGVD, was estimated at 625 c.f.s.
